Manhole Inspection Summary

Manhole # S33A1_001MH

Insp Date: **2/10/09 10:47 AM**

Location Address: **151 w mcomas st**

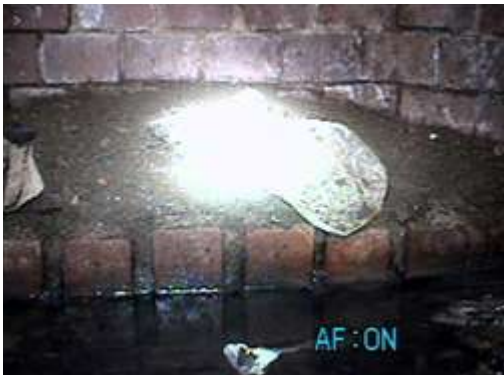
Defect 5

Condition: ☐ Sound ☐ Cracked ☐ Root Intrusion ☐ Deteriorated ☐ Leaks ☒ **Debris**

bench debris

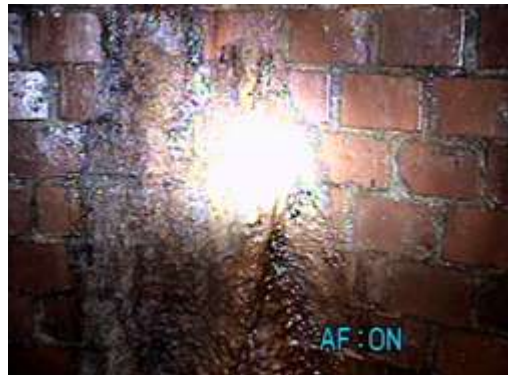
Defect 4

Infiltration: ☐ None ☐ Joint ☒ **Cracks** ☒ **Mortar** ☐ Roots ☒ **Wall**

barrel infiltration

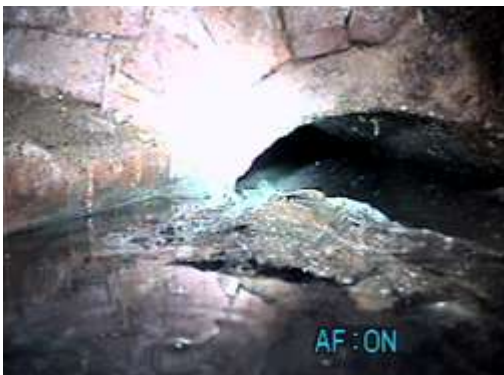
Defect 3

Condition: ☐ Sound ☐ Cracked ☐ Root Intrusion ☐ Deteriorated ☐ Leaks ☒ **Debris**

channel debris

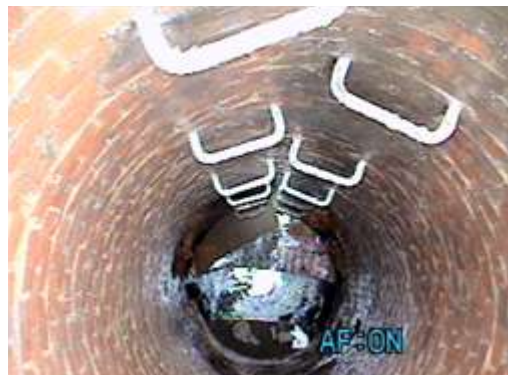
Defect 2

Steps Count: **11** Missing: **0** ☒ **Corroded**

cor. steps

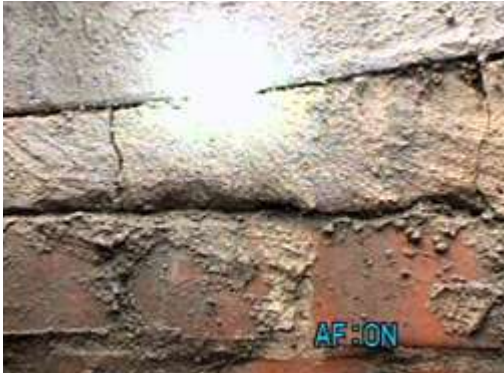
Defect 1

Condition: ☐ Sound ☒ **Cracked** ☐ Root Intrusion ☐ Loose Brick ☐ Deteriorated

chimney cracked, frame adj

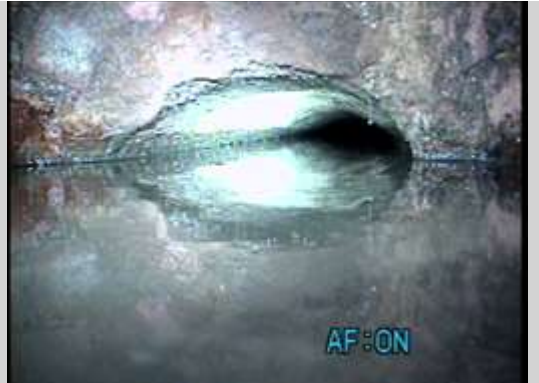
12 O'Clock Outflow

15 in. Circular Gravity Sewer
Pipe Out @ 12 O'Clock

Invert Depth: **18.00** (ft.) Flow Characteristics: **Slow**

Deposits: ☒ None ☐ Mud ☐ Sludge ☐ Debris ☐ Grease

Infiltration: **None** Pipe Seal Cond: **Unknown**

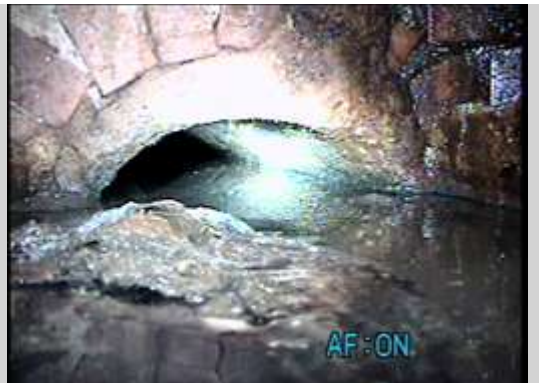
5 O'Clock Inflow

15 in. Circular Gravity Sewer
Pipe In @ 5 O'Clock

Invert Depth: **17.92** (ft.) Flow Characteristics: **Slow**

Deposits: ☒ None ☐ Mud ☐ Sludge ☐ Debris ☐ Grease

Infiltration: **None** Pipe Seal Cond: **Unknown**
